An Taisce
The National Trust for Ireland

Buildings at Risk

November 2014

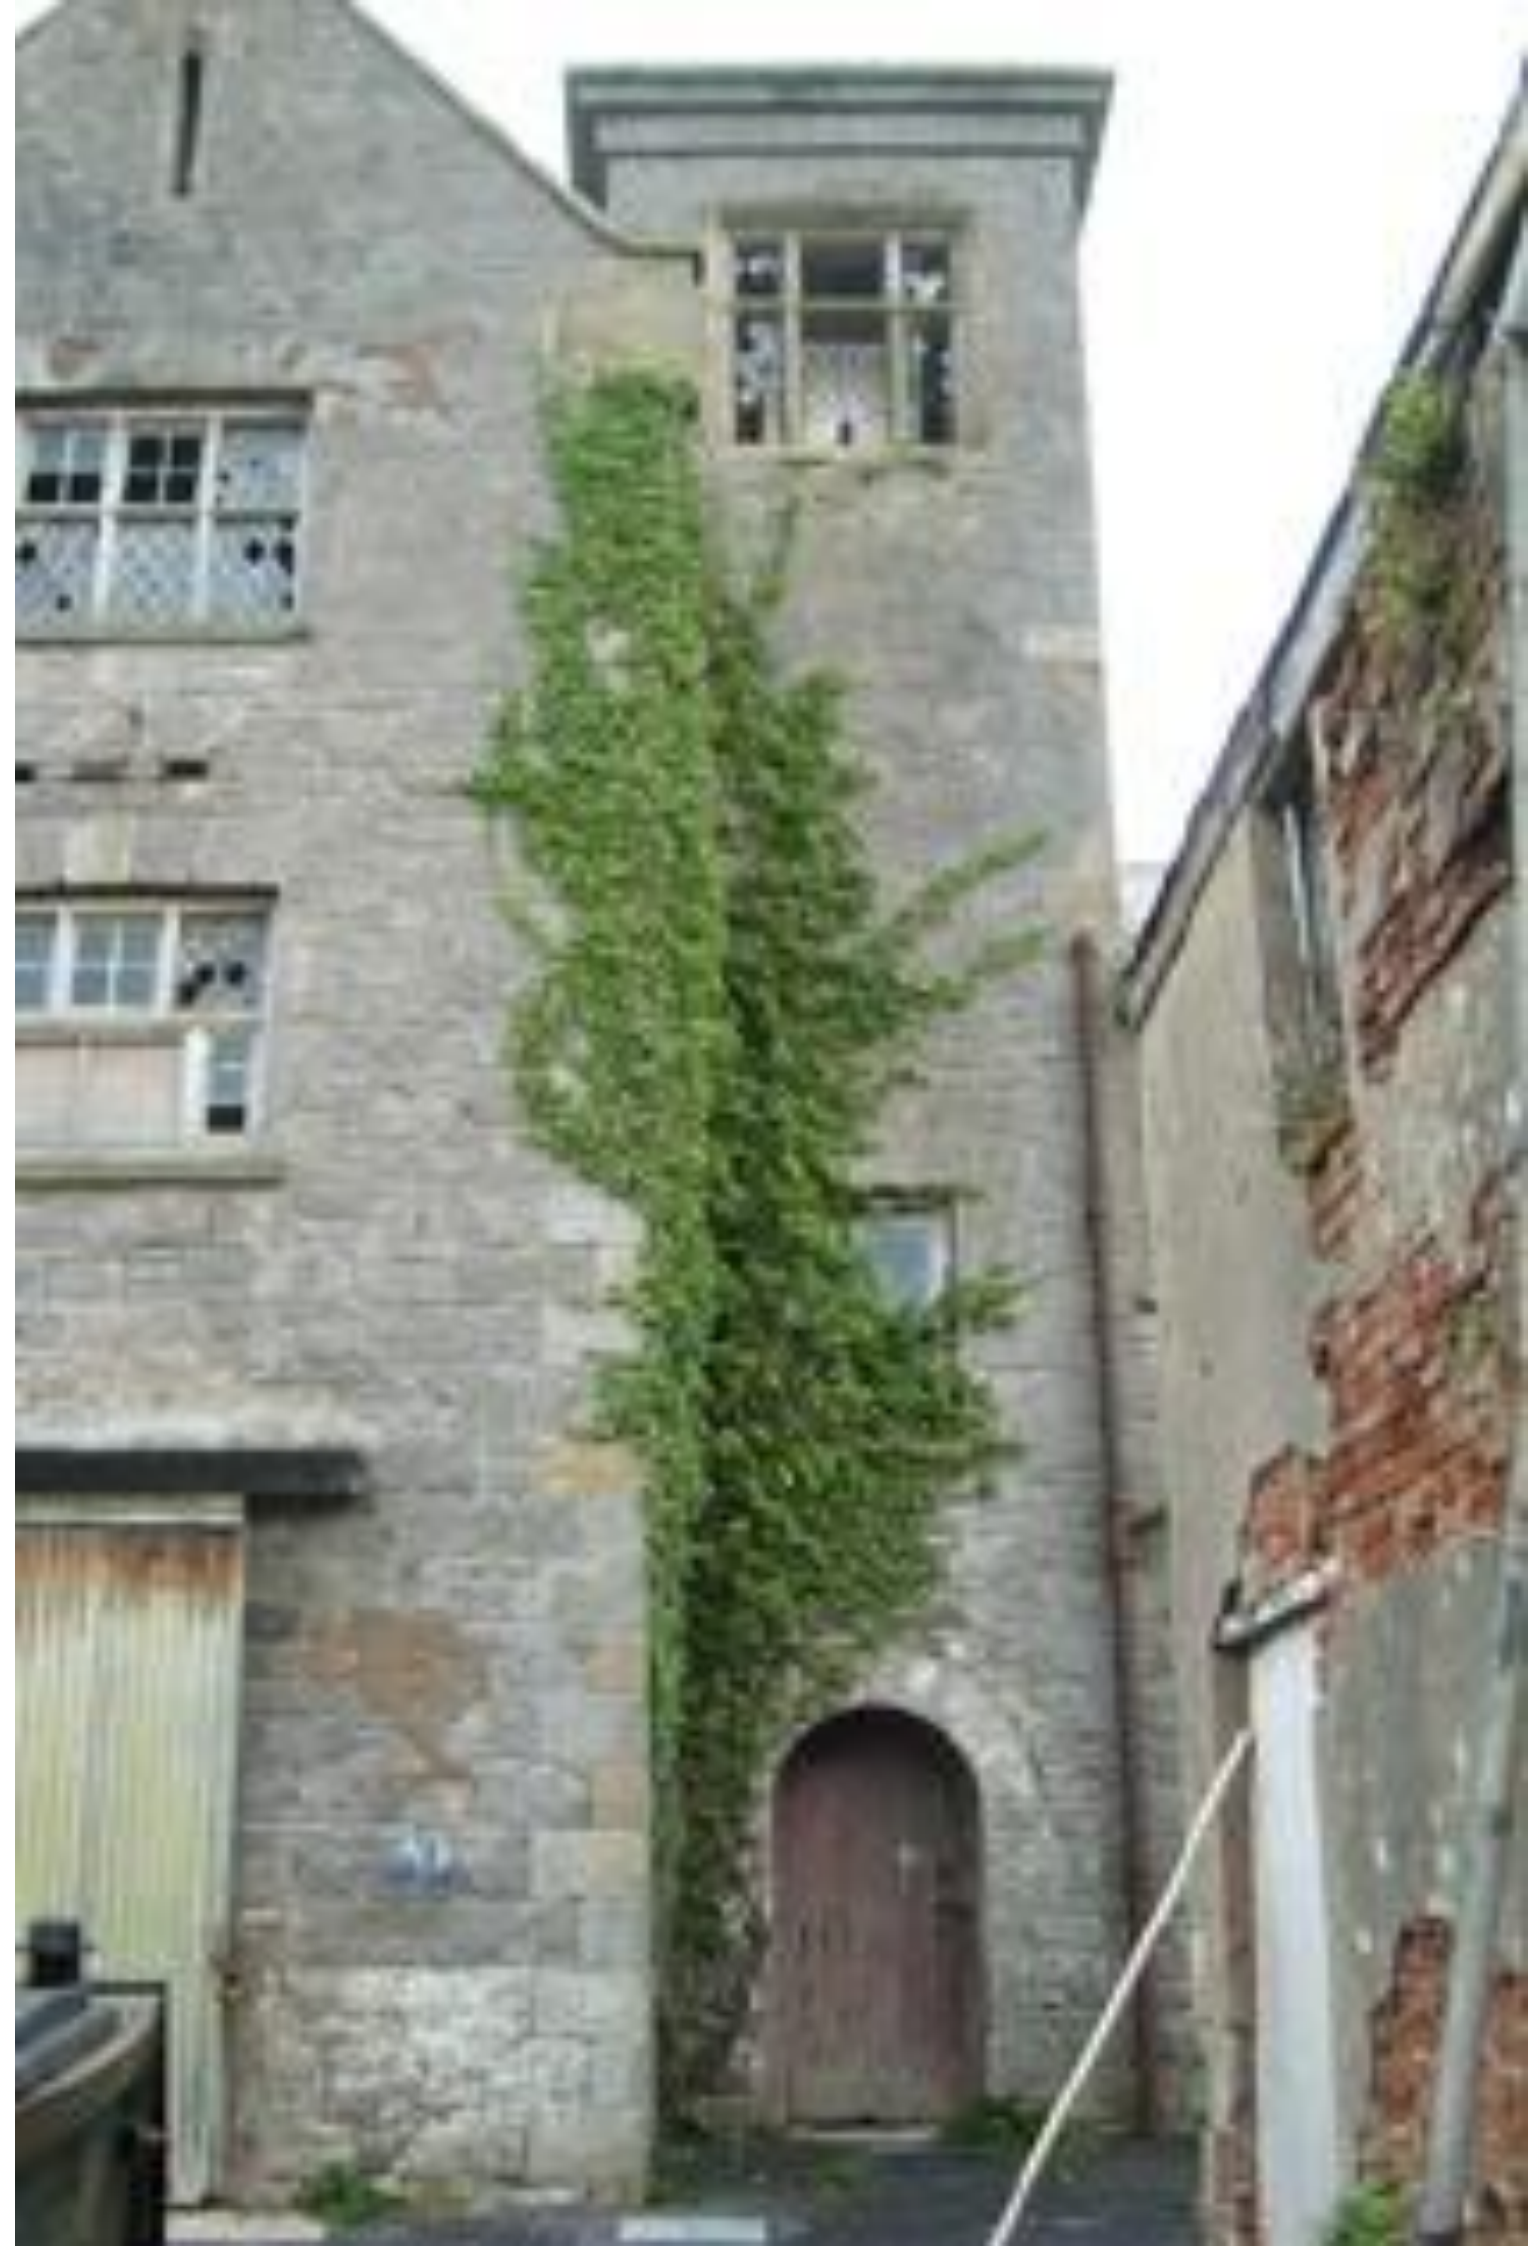
Rock House is a workhouse of the mid 1840's built to standard design of George Wilkinson. Constructed with attractively cut local limestone, this forms a prominent landmark on the height overlooking the southern bank of the Erne towards the town centre. The main block forms along two storey range with double gabled three storey sections at each end with some original latticed windows. It is in excellent structural condition with a good roof, but neglected vegetation now likely to cause problems. This building urgently requires new uses to be identified to prevent further deterioration of its character.

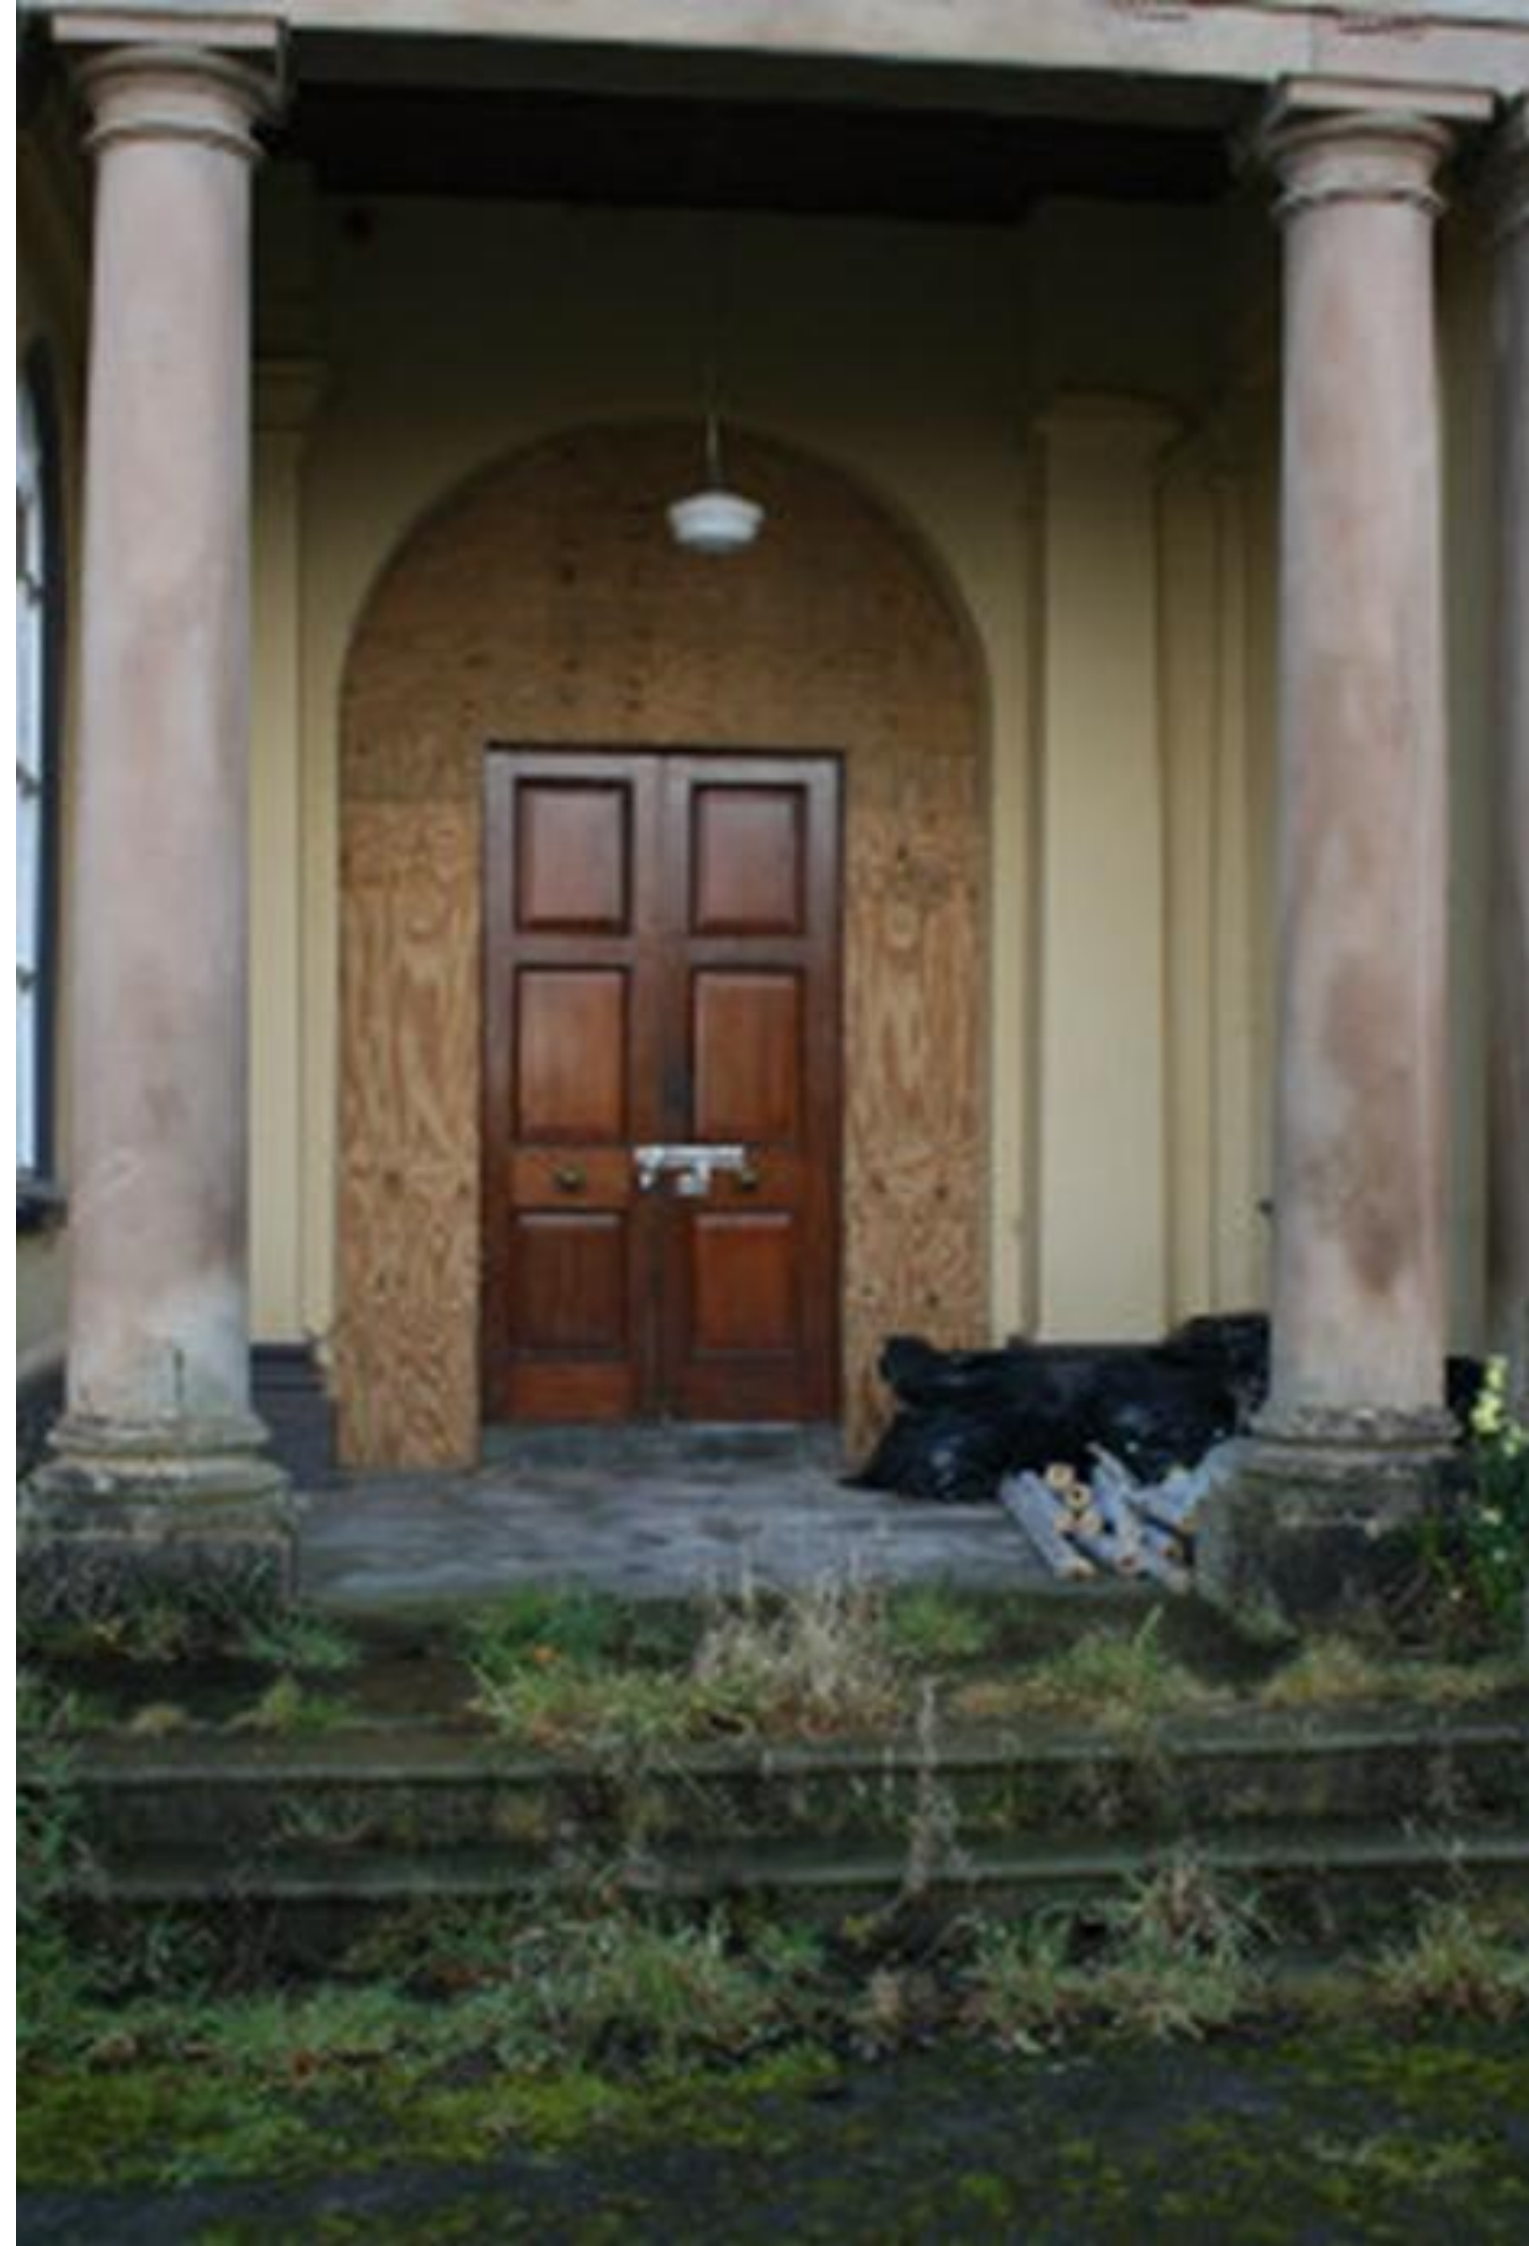
A country house has existed on this site since the 17th century, though the current structure only dates from 1824. Having operated as a barracks for a number of years, the building has been vacant since 2008 when the Department of Defence withdrew operations from Letterkenny and the barracks became redundant. This building urgently requires new uses to be identified to prevent further deterioration of its character.

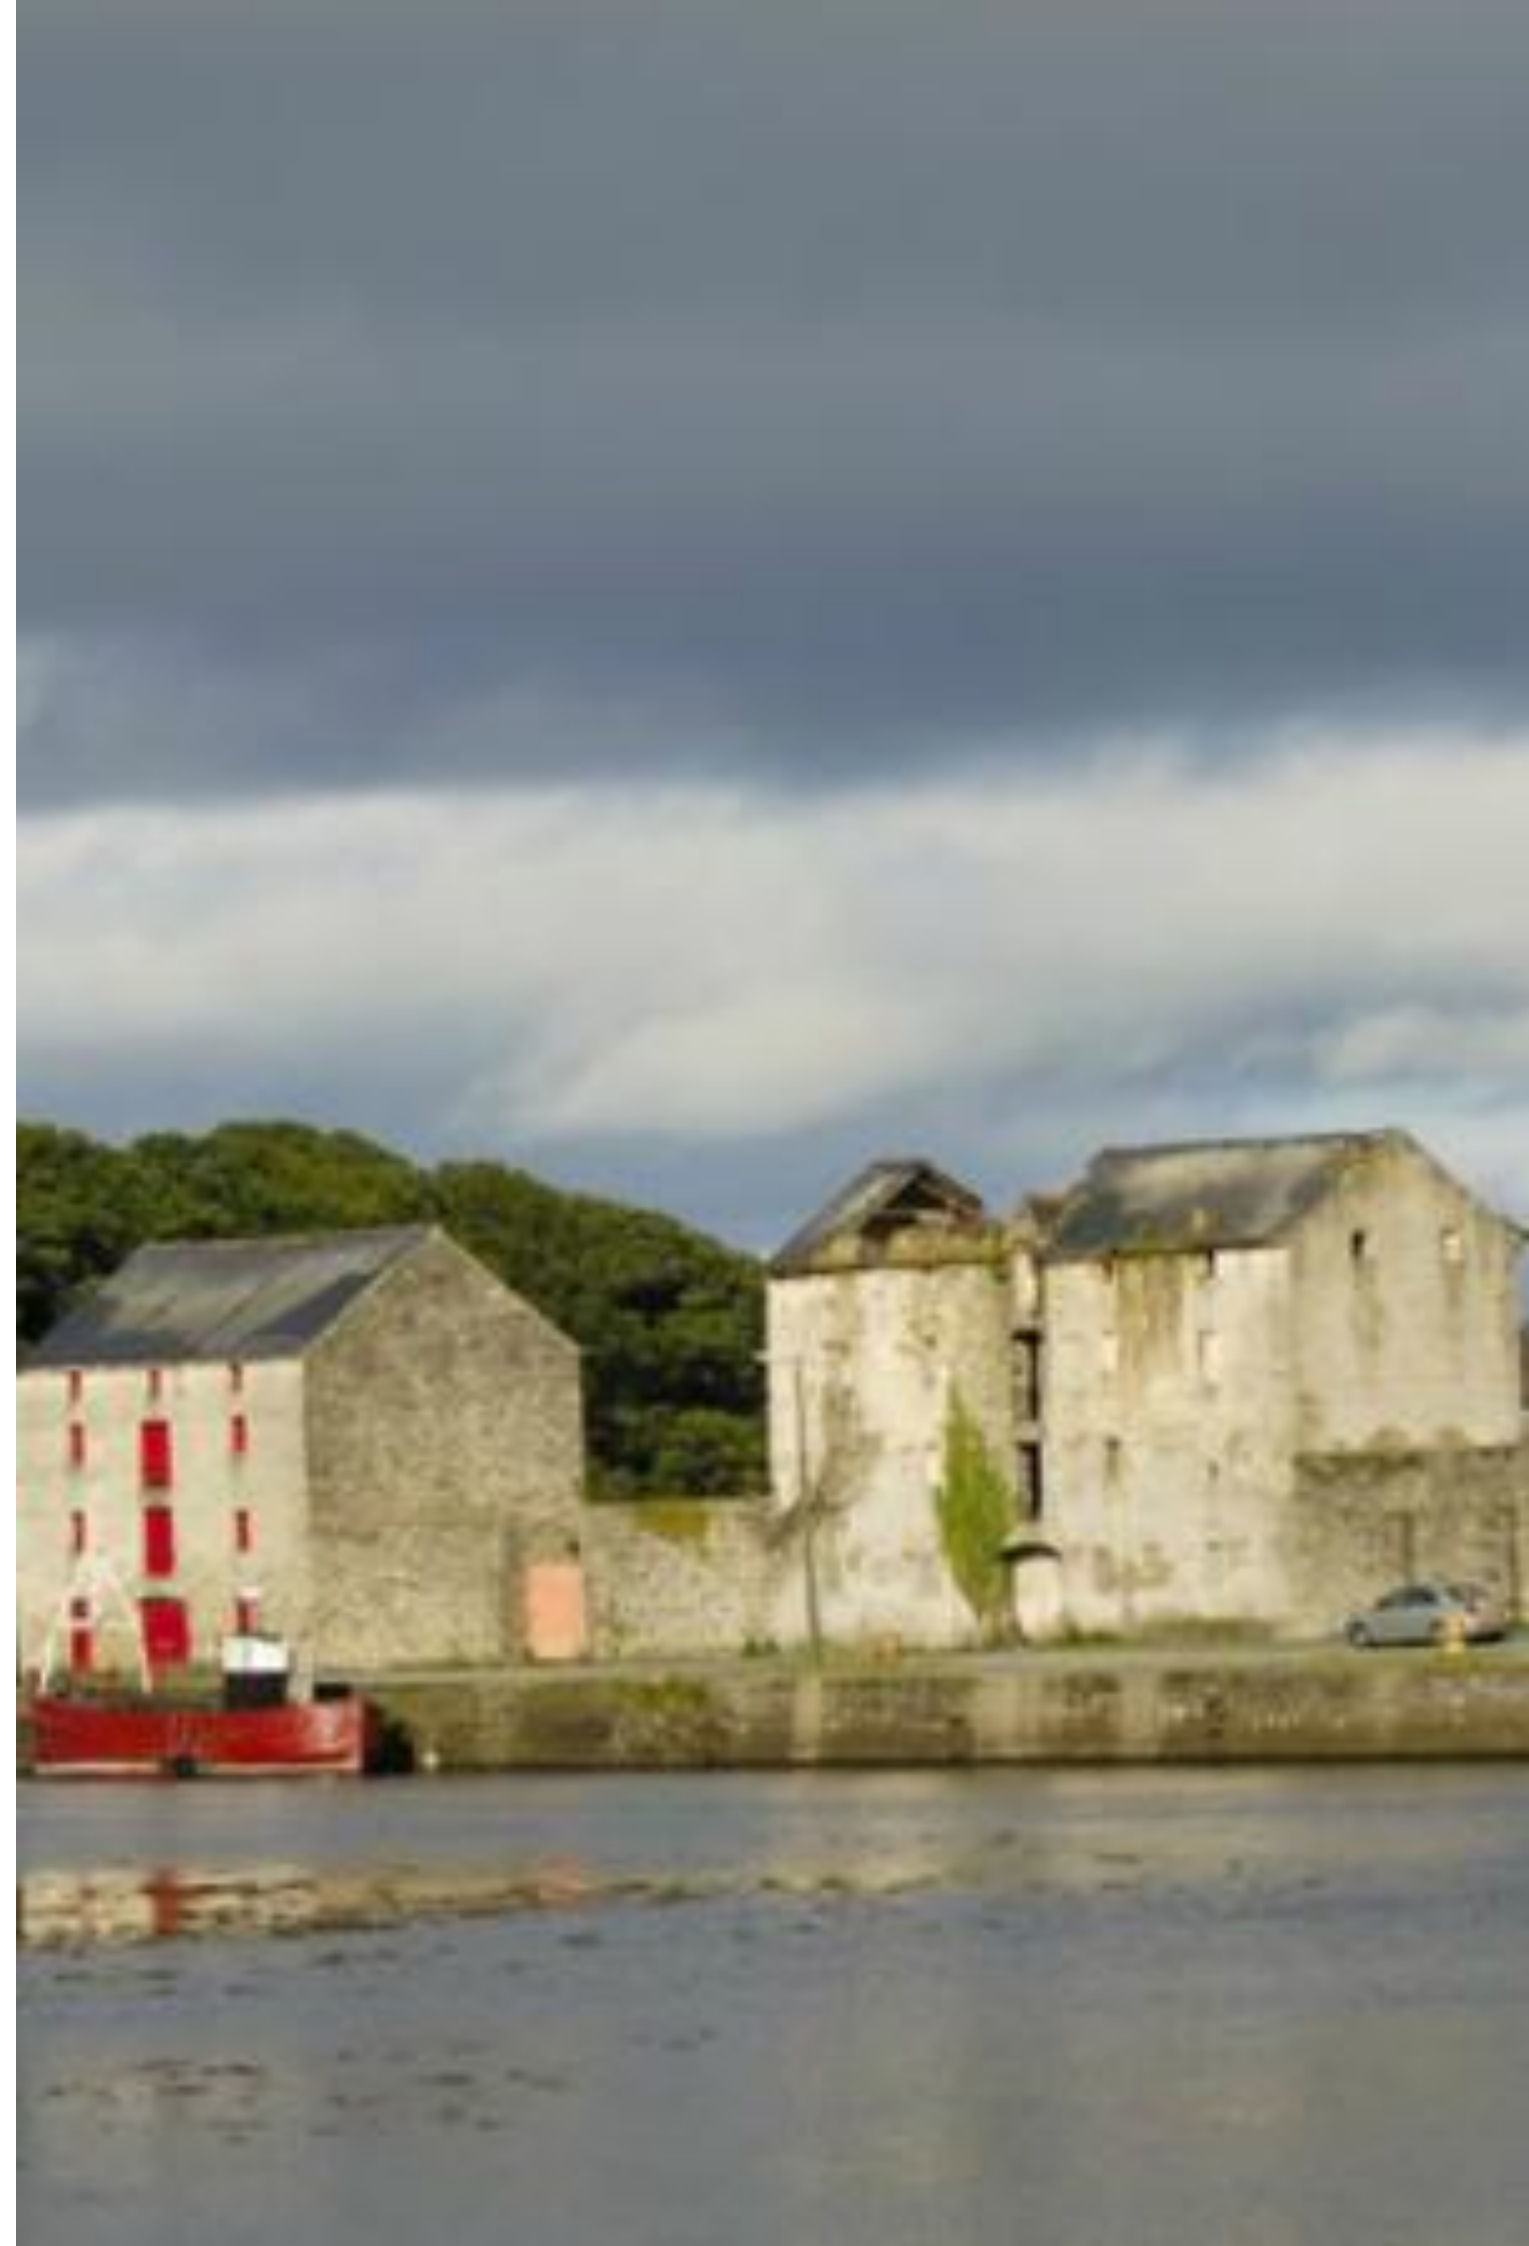
The group of quay front warehouses of the mid 19th century reflect Ramelton's historic status as a sea port. There are two buildings which have become progressively derelict over a number of years. The picturesque structures are a key feature of this historic townscape. The structure is of significant historic importance and requires conservation works to prevent further deterioration.

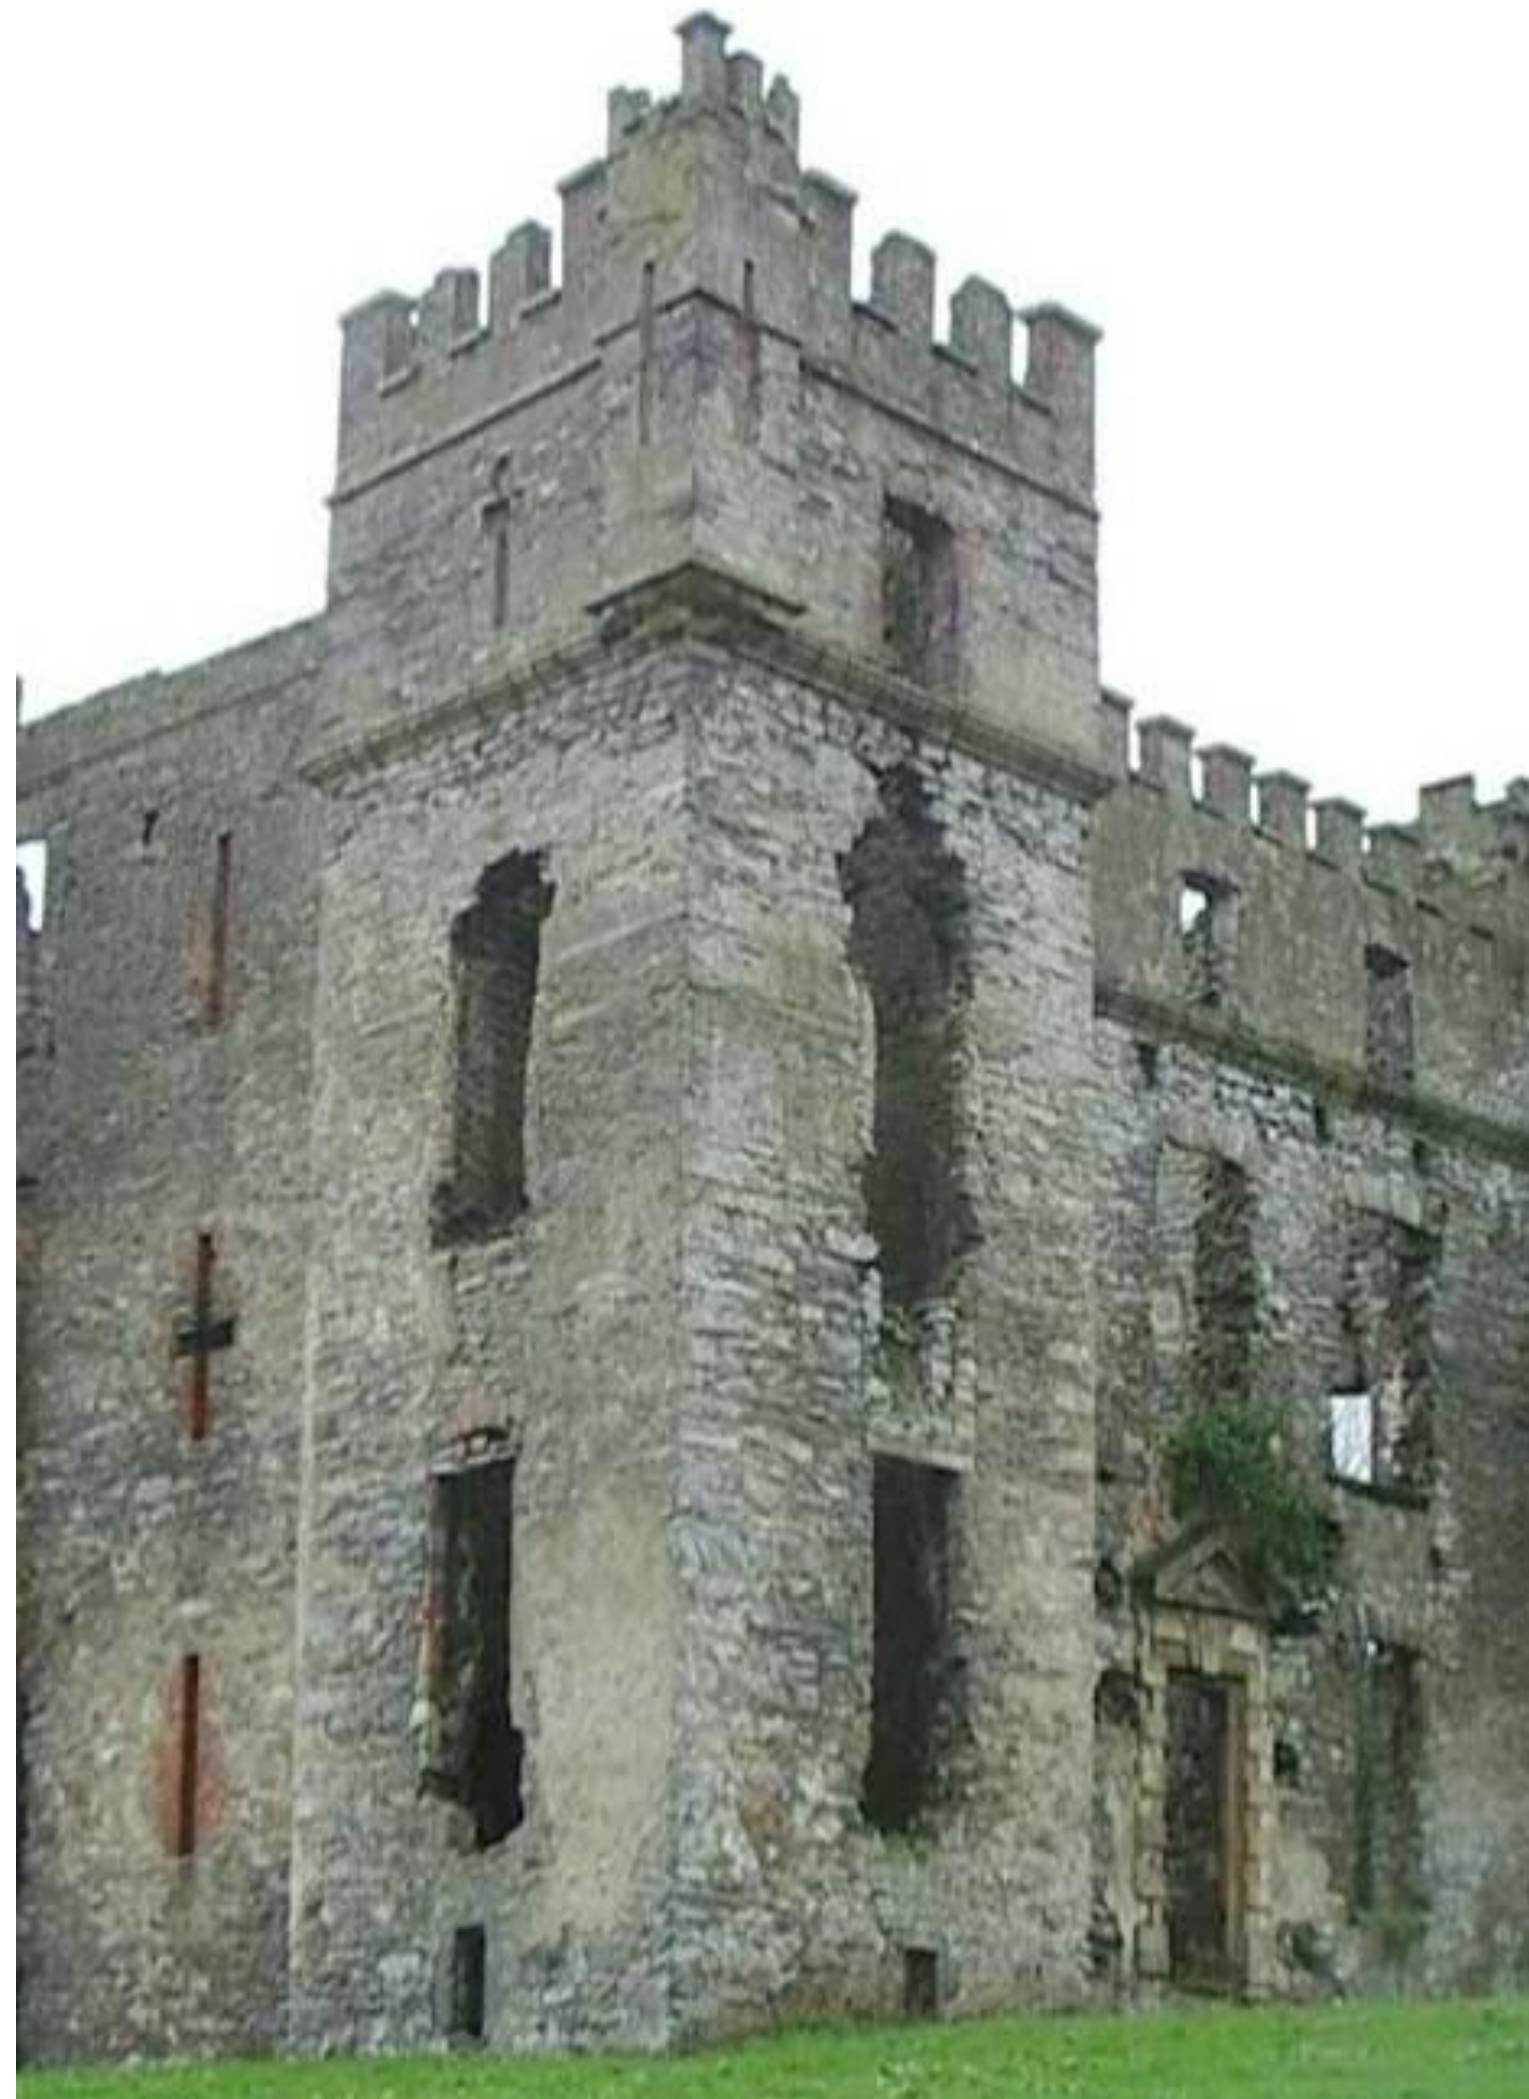
The Bishop's Palace is an early 17th century fortified mansion with four corner towers built by Bishop John Lestie. Some alterations were carried out in mid 18th century including a classical doorcase. It was left to ruin in the mid 19th century after the merging of the Diocese with Derry. The structure is of significant historic importance and requires conservation works to prevent further deterioration.

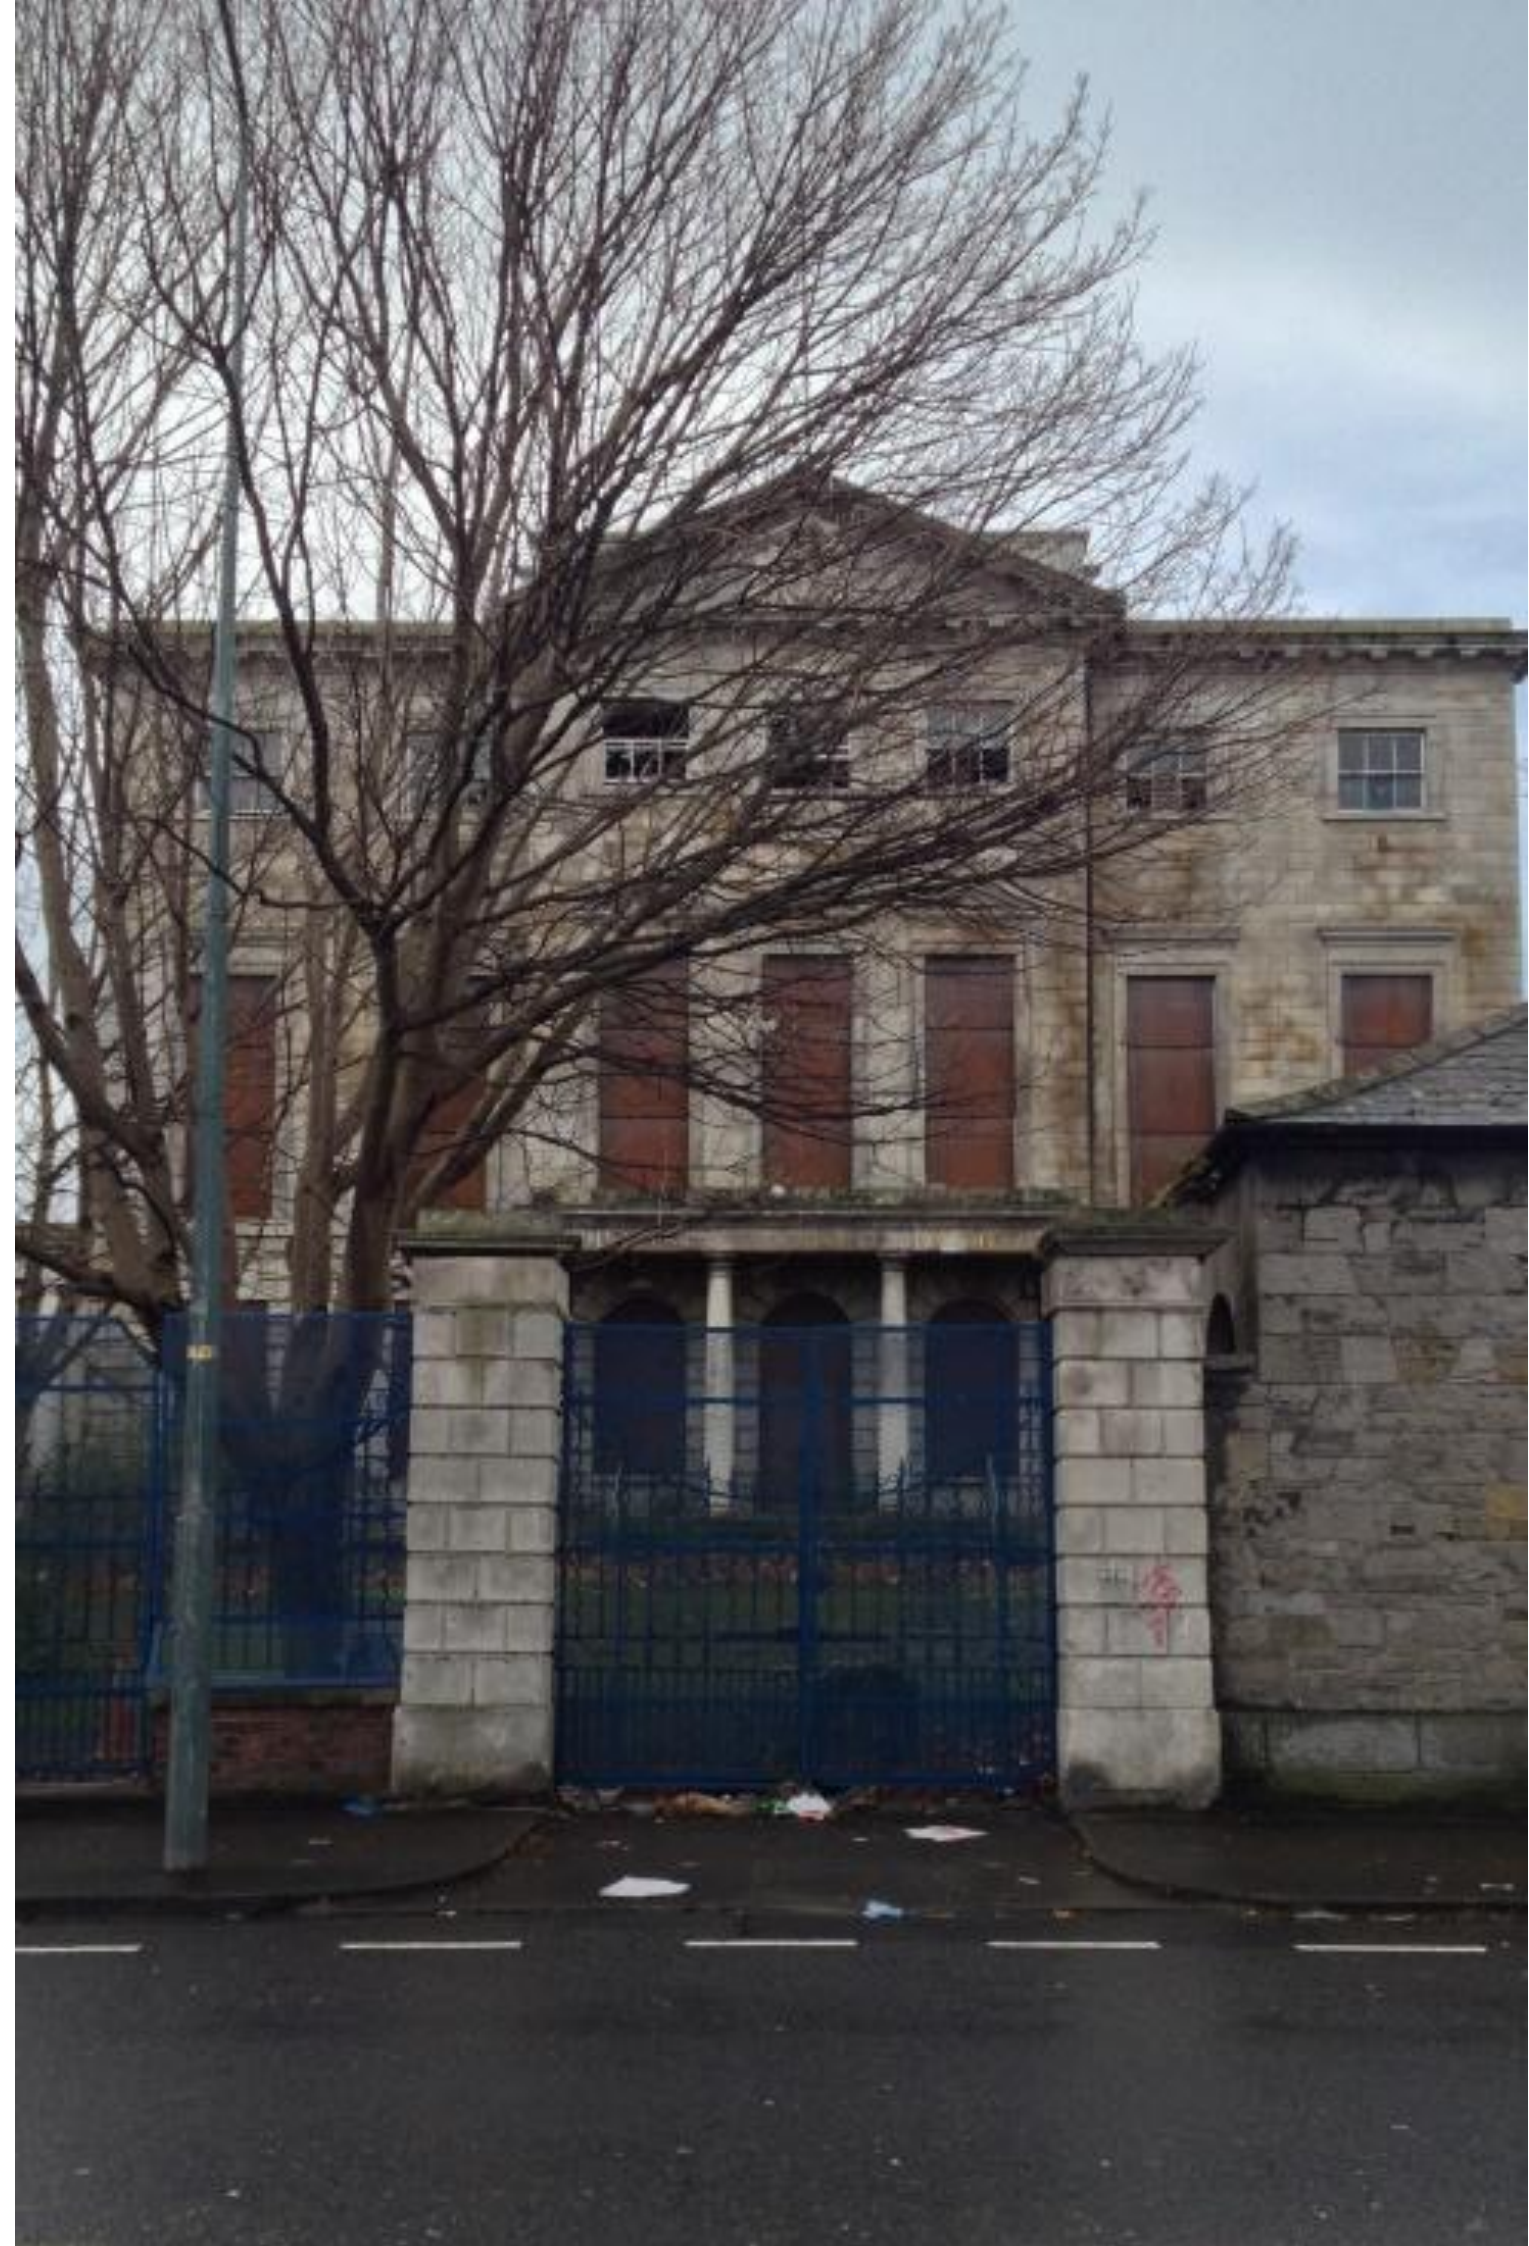
The last major Dublin Georgian Townhouse, second in size only to Leinster House was built from 1795 for the 2nd Earl of Aldborough. It was vacated circa 2000 and sold by the State. Two development proposals permitted have not proceeded. Major damage occurred to the roof valleys and gutters in 2010 with water saturation now seriously affecting the integrity of the building, which is highly visible on front and west elevations. Roof repairs have been carried out by Dublin City Council. This building urgently requires new uses to be identified to prevent further deterioration of its character.

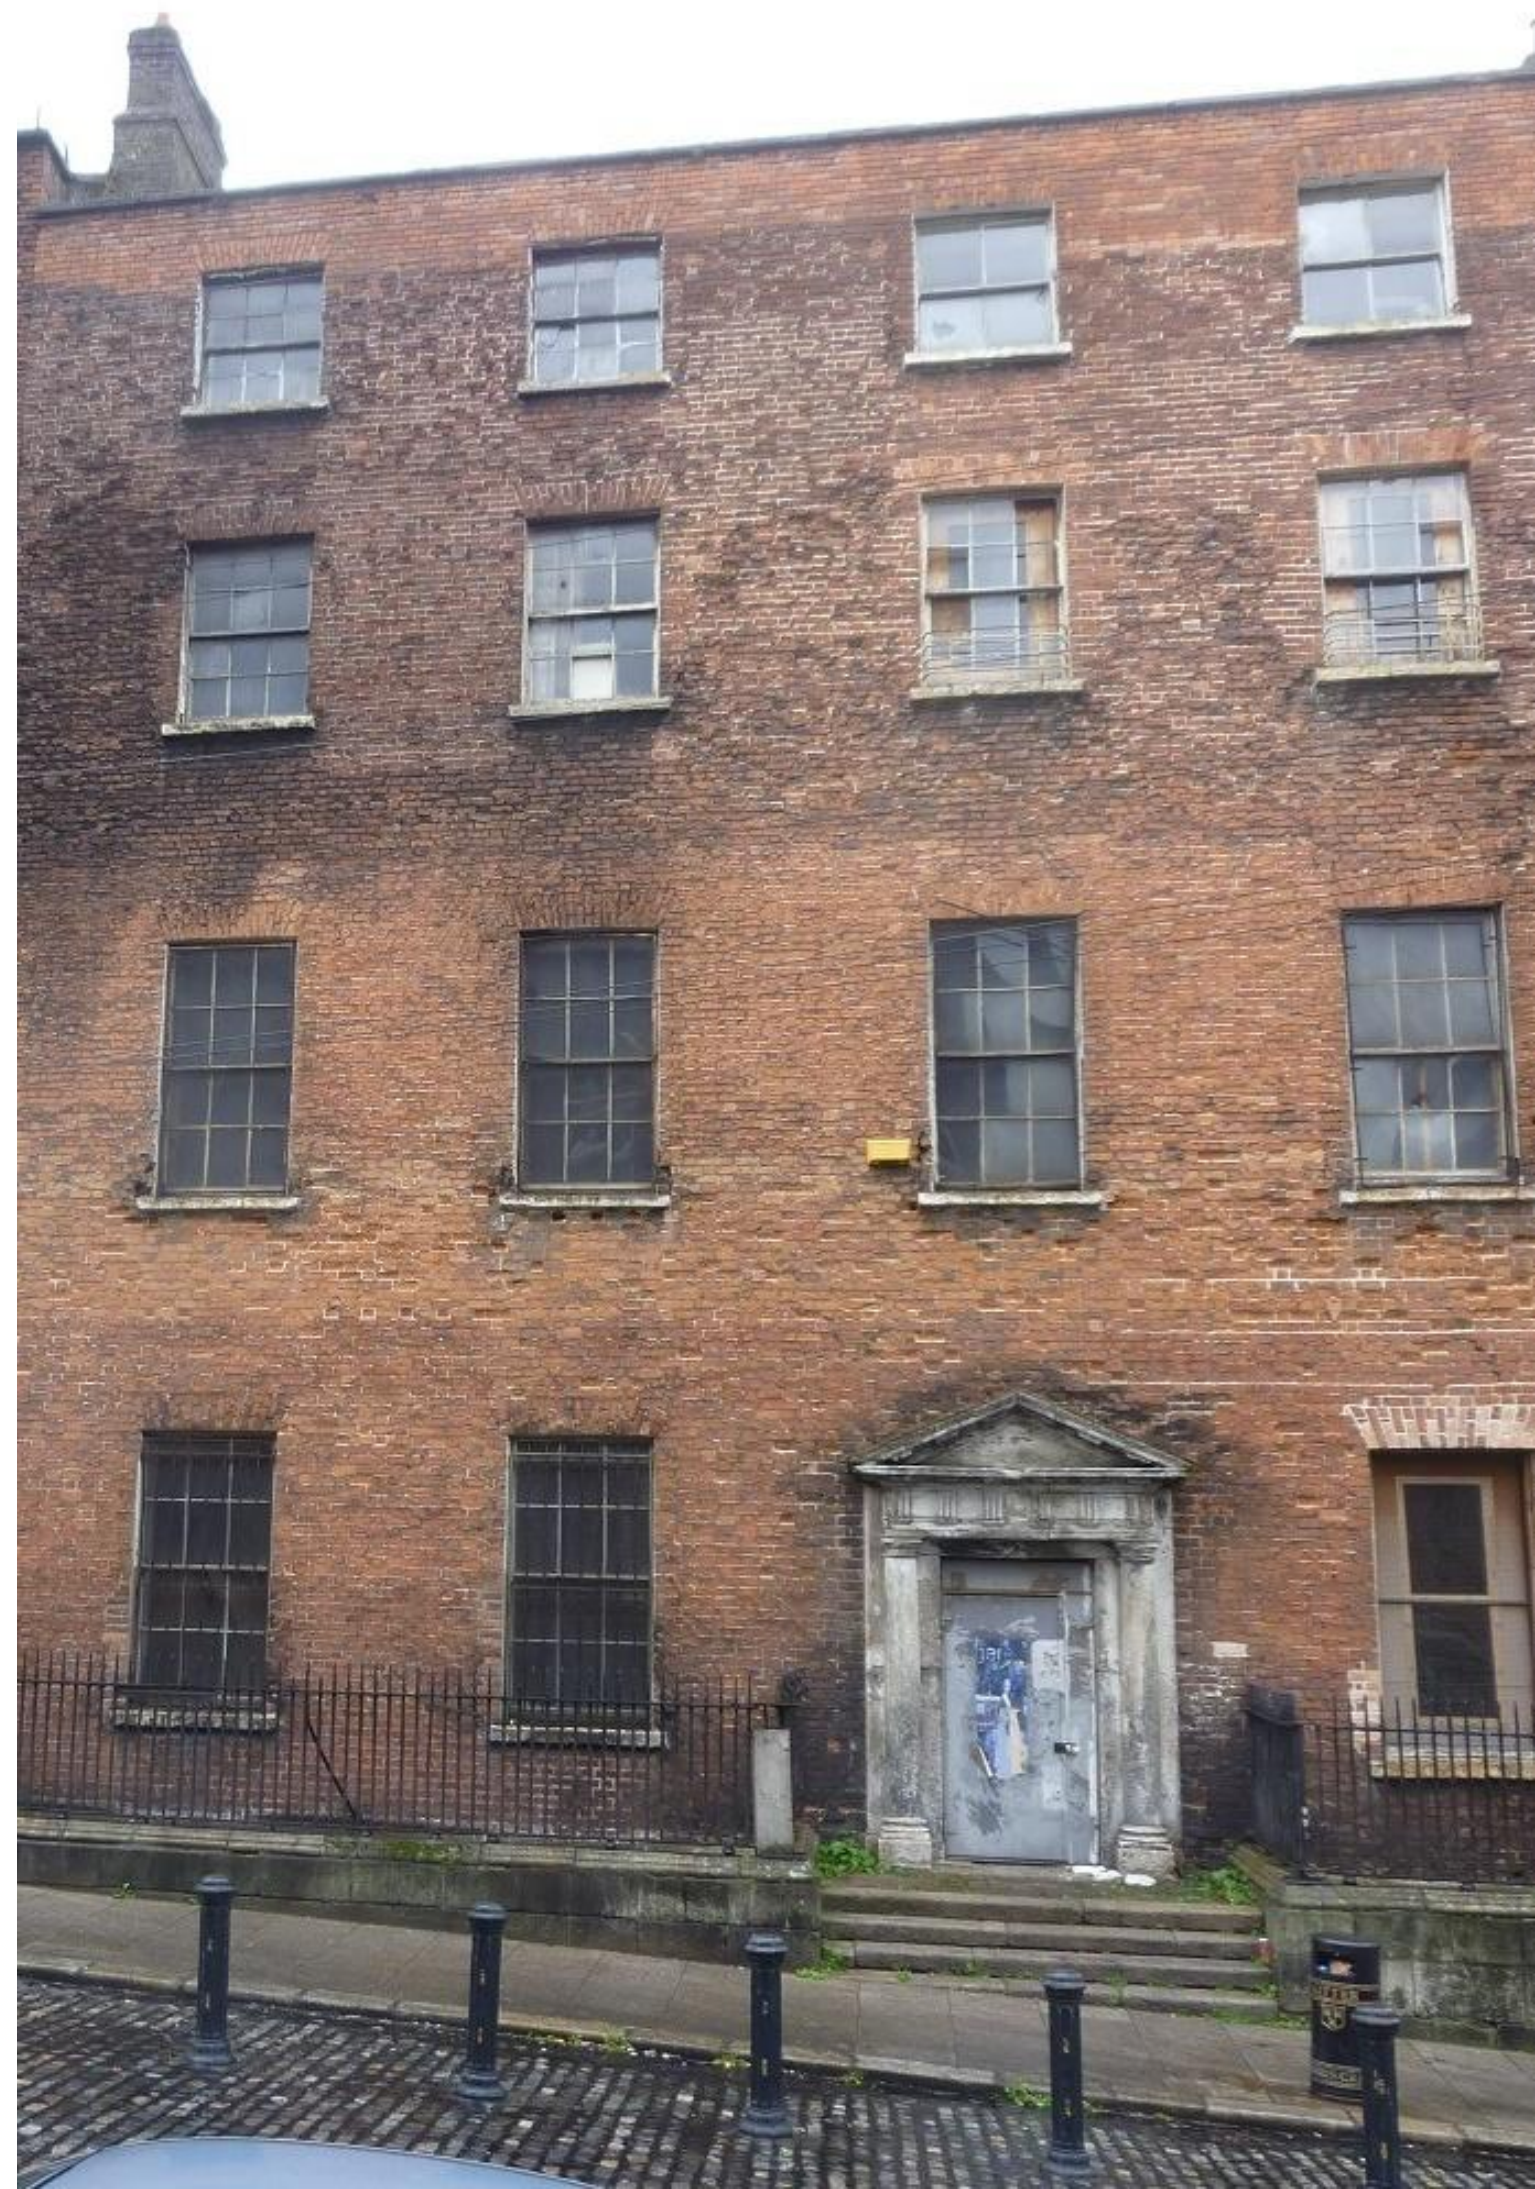
Its location on Henrietta Street makes it part of one of the most important groups of Georgian townhouses to survive in Ireland. No. 3 was built in circa 1755 for Owen Wynne, MP and contains spaciouly proportioned interiors with good quality plasterwork and carved woodwork. The house is held in the ownership of Marie Underwood, who has over many years repeatedly declared her aim to restore it as a museum. However, no such works have been carried out although structural stabilisation works carried out by Dublin City Council. A fire occurred in the building in October 2014 as a result of tyres being stockpiled in the basement. This building urgently requires new uses to be identified to prevent integral features being gradually lost.
